DATE: DECEMBER 1990

TO: ALL EXEC 90 BUILDERS

EXEC 90 MANDATORY COMPLIANCE BULLETIN-01

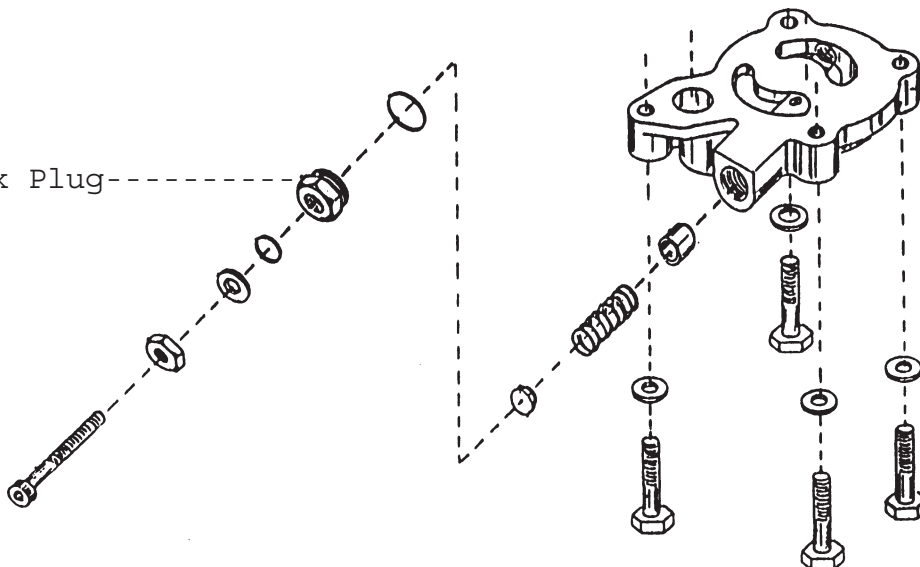
24-2454
3/4" Hex Plug

Part number 24-2454 oil pressure adjustment plug (3/4" hex) Apply a reference mark on both the 3/4" hex plug and the aluminum casting before loosening (Do not loosen the 1/2" hex nut or move the socket head adjustment bolt.)

Unscrew the 3/4" hex plug and carefully remove it, the 5/8" round steel backing plate, and the spring. Clean all the threads on both the engine and parts thoroughly with acetone or equivalent and re-install before oil begins to seep into the threads. The spring goes in first. Then the backing plate registers in the spring I.D. followed by the cleaned plug with the fiber washer and #242 Loctite on the threads. Tighten to your initial reference mark and your oil pressure should still be calibrated.
