TO ALL EXEC 90 AND EXEC 162F OWNERS

MANDATORY COMPLIANCE BULLETIN M-17**THIS BULLETIN IS MANDATORY AND MUST BE COMPLIED WITH**

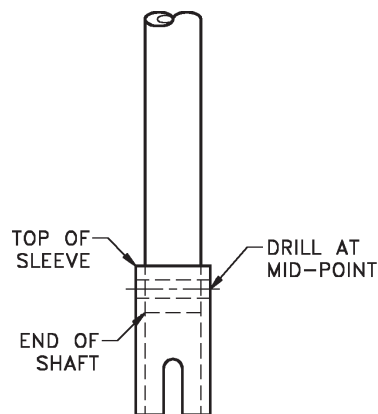
FIGURE 1

Remove and disassemble the passenger (dual) collective stick. Inspect the welds that attach the sleeve to the shaft. If there is a weld completely around the end of the sleeve (as shown in Figure 1 below), no further action is necessary. This is most likely to be the case in non-Quick Kit Exec 90 models.

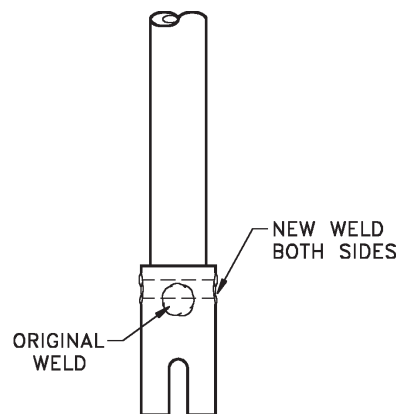
FIGURE 2

History: The Dual Throttle Shaft Weldment (part number E15-9021) consists of a short sleeve attached to the throttle shaft by means of a rosette weld. (This type of weld is made by drilling through the outer sleeve, then welding in the hole to join the two pieces.) Slight misalignment could cause the weld to fatigue and break, resulting in loss of throttle control in the passenger (dual) collective stick.

If the sleeve is attached with only a rosette weld, find the mid-point between the top of the sleeve and the end of the shaft. Drill a hole all the way through, 90 degrees to the original rosette weld, using a 1/8 inch drill bit. (See Figure 2 below.)
