Date: August 30, 2018

**TO A600 TALON OWNERS
AND ROTORWAY OWNERS WITH ELECTRIC CLUTCH ACTUATORS
MANDATORY BULLETIN M-28**

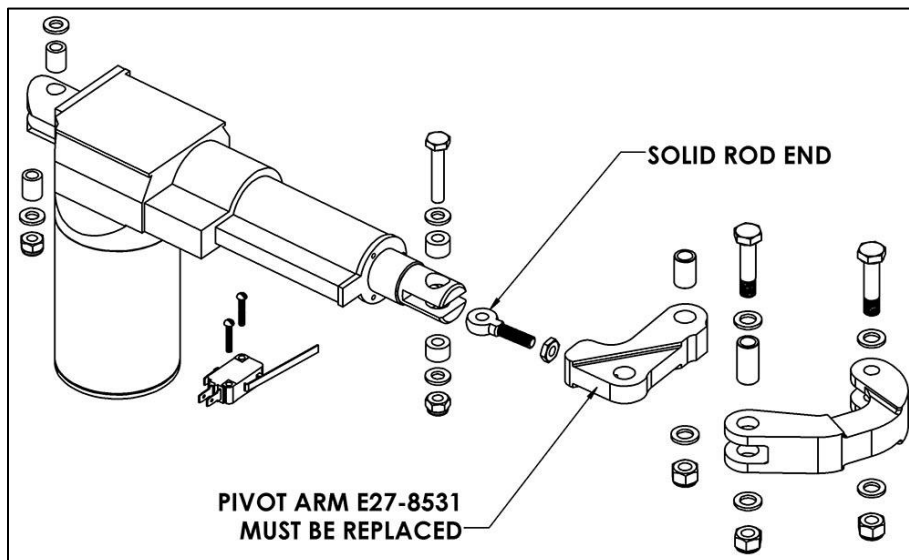
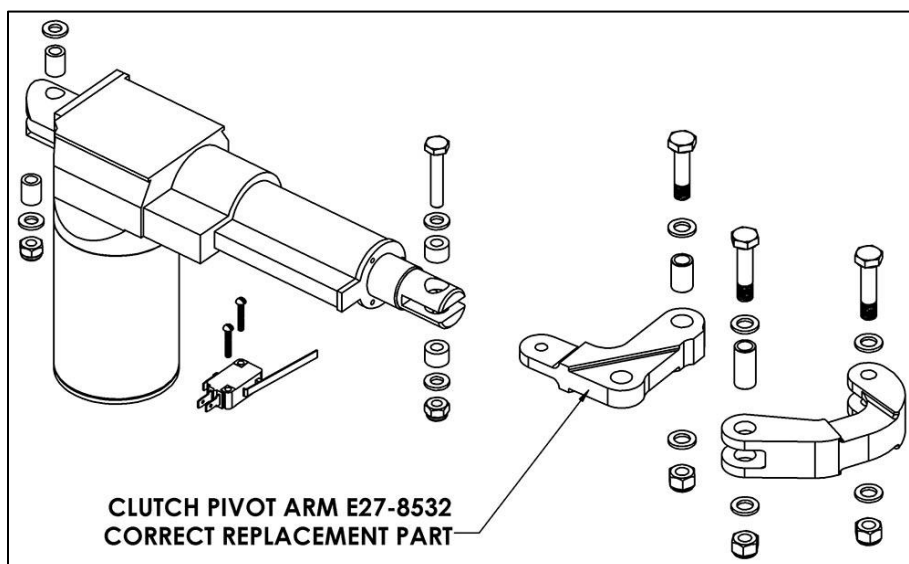
History: There has been one instance of failure of a solid rod end on the clutch pivot arm of the electric clutch. The pivot arm has been re-designed to eliminate the rod end.

Action: On any electric clutch actuator with clutch pivot arm part number E27-8531 (with solid rod end), the pivot arm must be replaced with the new part, E27-8532. If the pivot arm on your helicopter is the earlier type, E27-8530, replacement is not necessary.
